Possible Damages and Weak Points of Solar Thermal Collectors

INFO SHEET No. 04

The Catalogue of Possible Damages and Weak Points

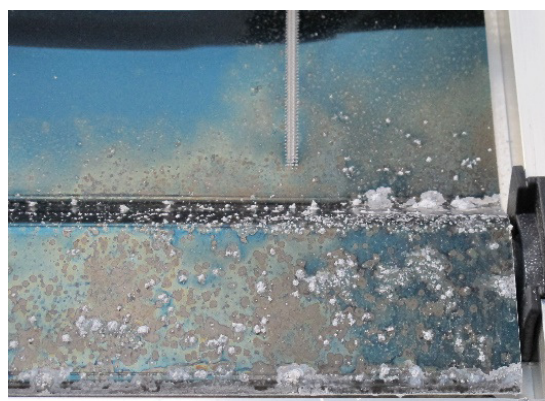
Figure 1: Salt deposition and corrosive degradation of the absorber layer near a pipe

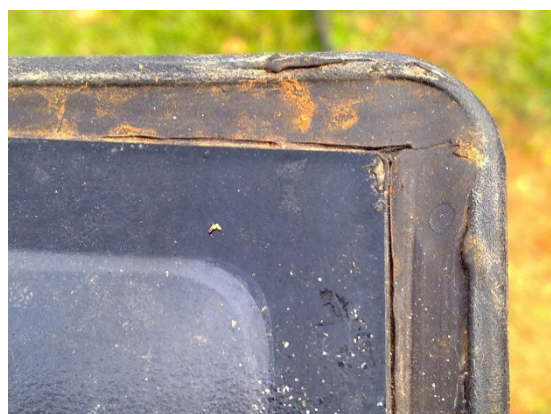
Figure 2: Degradation of the bond between glass cover and collector frame

- Mechanical impairment of metallic components by galvanic coupling of different metals, especially under salt load.
- Reduction of stability, deformation or breakage of the collector casing or the mounting kit due to strong wind and snow loads
- Reduction of the stability of plastic components due to very low temperatures, very high temperatures or UV radiation
- Loss of effect of adhesives or sealants at very low temperatures, very high temperatures or condensation of water and / or formation of microorganisms or algae on adhesives and sealants (see Fig. 2)
- Breakage of the cover due to hail, thermal cycling or heavy wind and snow loads

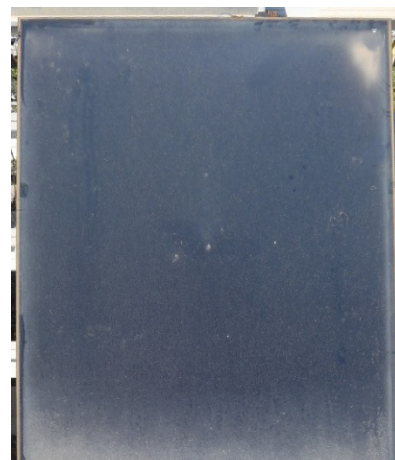
Figure 3: Collector with caked-on dirt on the cover and dirt entry through a pipe penetration
